PHASE I MILESTONE INSPECTION

Island Dunes Oceanside Condominiums

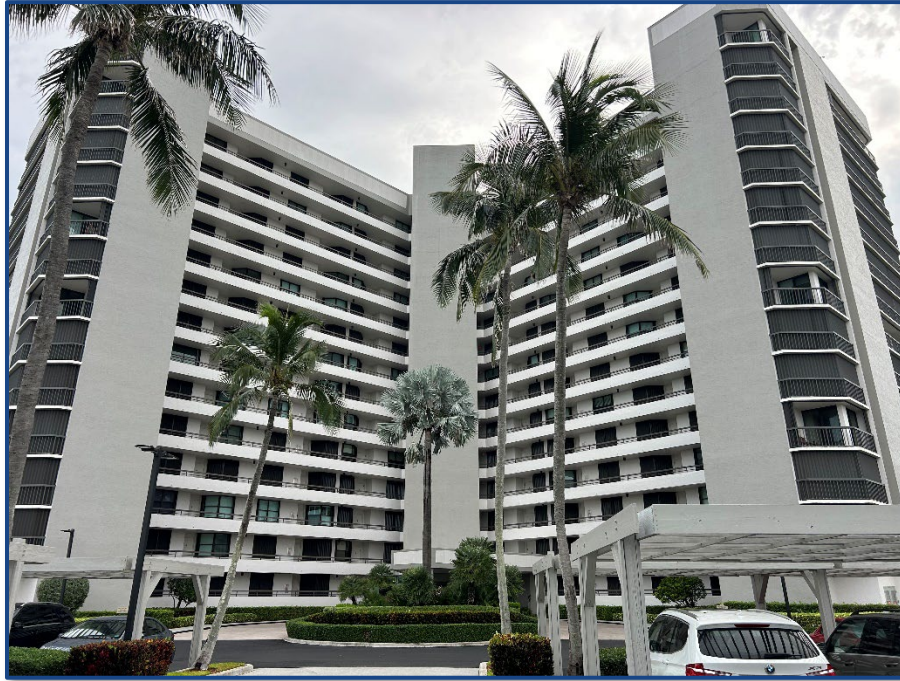
Photograph No. 1: Western elevation.

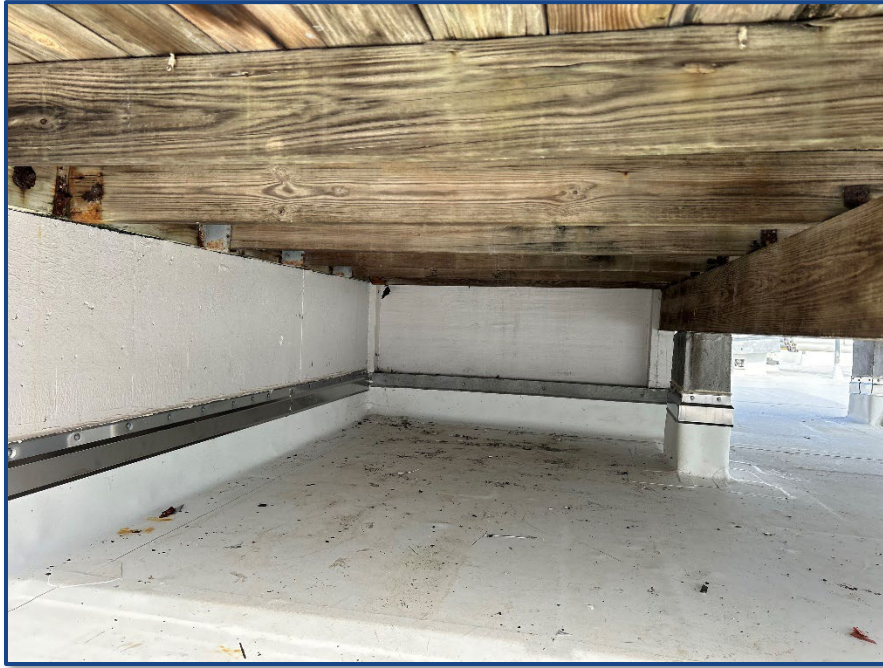
Photograph No. 17: Wood roof deck at the west side of the roof with rusted clips and bolts.

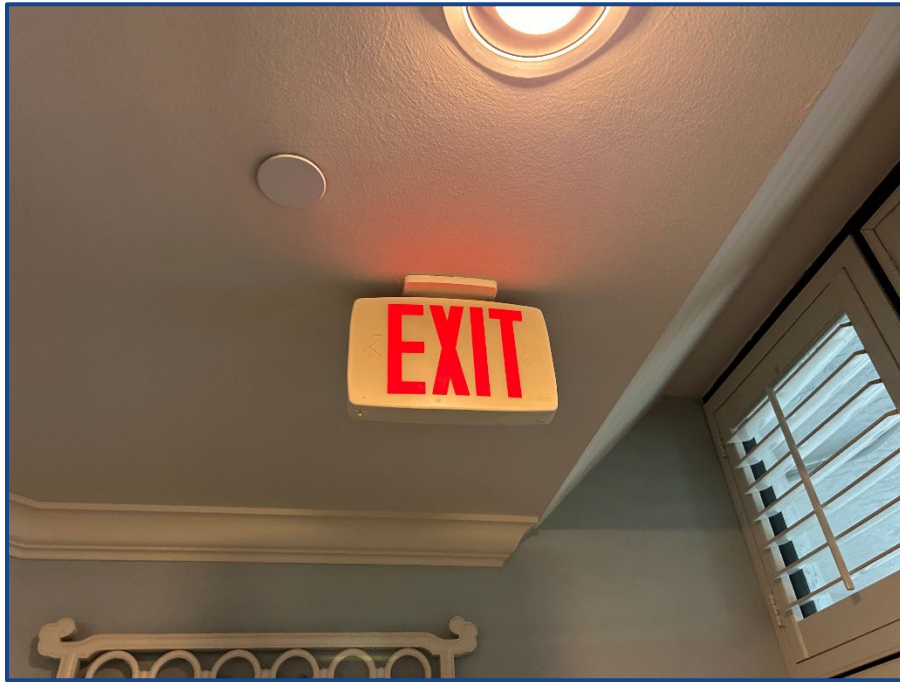
Photograph No. 18: Typical exit sign located in the first floor lobby.
